# BUILDING RECORDING IN 2018

SOMERSET VERNACULAR BUILDING RESEARCH GROUP

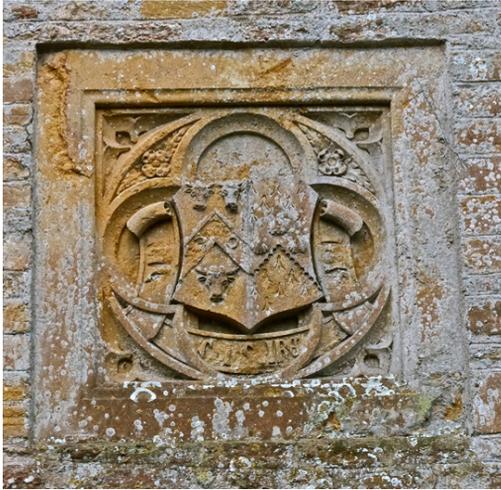
In the mid-19th century the lean-to was added, and a Troyte-Bullock coat of arms added to the west gable (Fig. 1), possibly reflecting the building of North Coker House and the acquisition of this property by the same family.

*Fig. 1 East Coker, North Coker, Chantry House,  
Troyte-Bullock coat of arms on west gable*

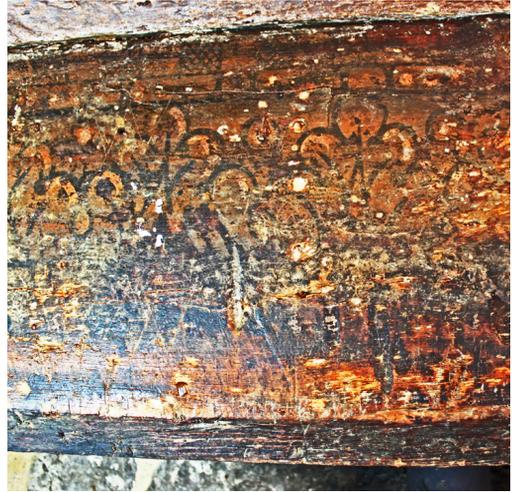
*Fig. 2 Isle Abbots, Pitts Cottage,  
Painted decoration on fireplace lintel*

A second phase is likely to accord with the date stone of 1583, the year when a John Pitt was born; it was possibly an investment by his father to mark this occasion. The property was upgraded; the central and a west gable fireplace were inserted as were the framed ceilings, one over the open hall. The central fireplace, backing on to the cross passage, is notable for its original floral painted decoration below a brick-like banded motif (Fig. 2). The painting itself has apotropaic marks scratched into it – the Marian mark ‘VV’ (virgo virginum) and a hexafoil (daisywheel).

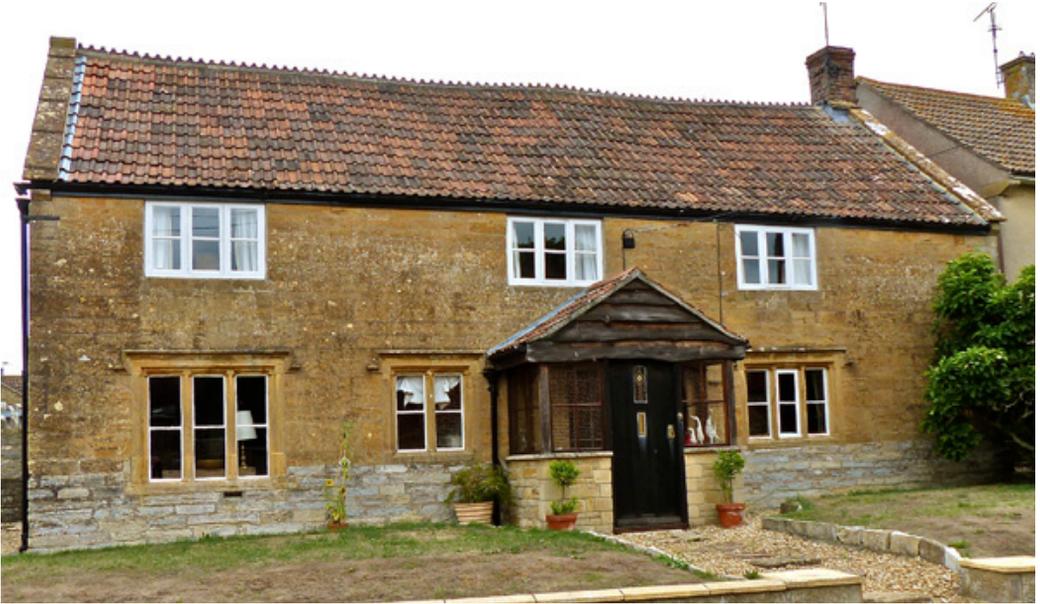
Once built of roughly coursed local lias stone, walls 0.6m thick, the front elevation is now Hamstone ashlar on a metre high lias plinth whilst the west gable is entirely of brick (Fig. 3). The roof is of double Roman clay tiles with cockscomb ridge tiles laid between raised and coped gables, indicating former thatch. It is now supported on three reworked elm trusses, two of which were formerly the upper elements of jointed crucks. One is smoke blackened suggesting an original smoke bay at the eastern

*Fig. 3 Kingsbury Episcopi, Kingsbury, Doke House, Front elevation with Hamstone walling on lias plinth*

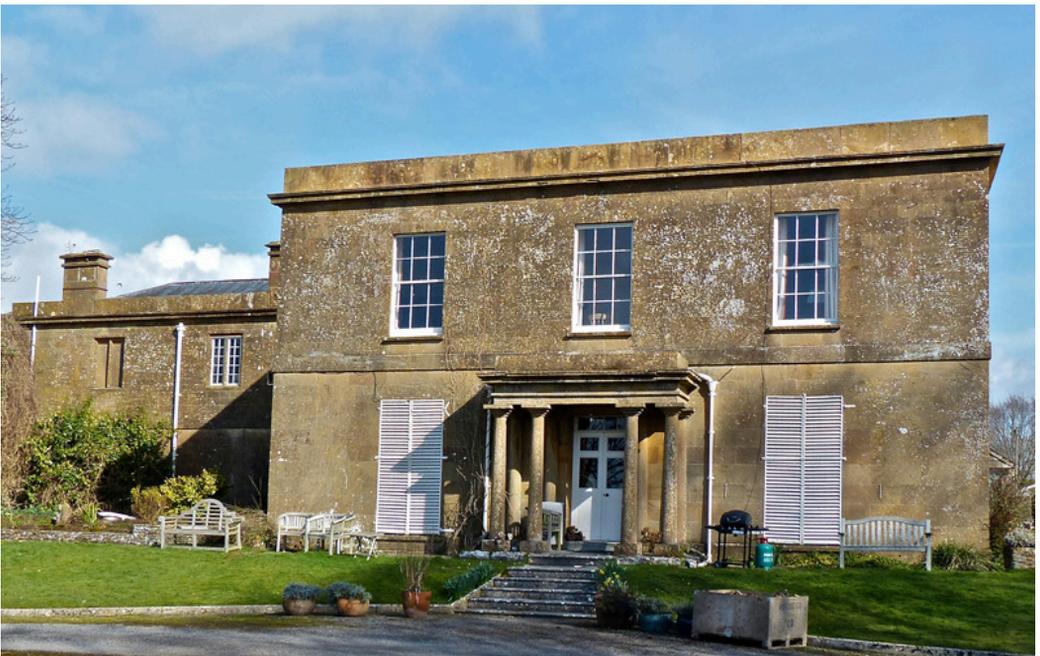
This classically styled listed house is square in plan, built in brick and clad in Hamstone ashlar with a pillared portico over the front entrance and built to a high standard ‘all of a piece’ (Fig. 4). A broad string-course separates the upper and lower floors, with a decorative cornice and parapet hiding the flat roof. The windows are symmetrically arranged, mainly six over six sashes, many with foldaway shutters. There are blind windows on the east and west walls. The two front ‘family rooms’ are separated by a central entrance hall that leads into the stair hall, two floors high and lit by an oval window in the roof. The other five rooms

*Fig. 4 Kingsbury Episcopi, New Cross, New Cross Farm, Classical front elevation and additional wing on west side*

To the west and aligned with the rear of the main building is a narrower, lower two-storey wing added in the mid-19th century. The use of two fine, but unmatched, 17th-century fireplaces and similarly dated two-light stone mullioned windows point to reuse from another building. To the rear a wider ground-floor window has been converted to a double-width door with steps down to the yard level. It is believed that the ground floor in this wing was not for domestic use but rather for farm processing.

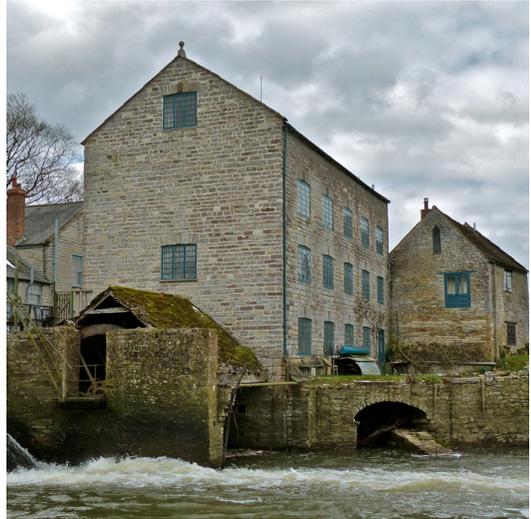
In 1777 (map evidence) the water wheel was located within in the building and there was also a horse engine house at the east end. The internal waterwheel was replaced in 1866 by a much larger (4.3m diam x 4.3m broad) wheel in an external wheelhouse set across the re-routed watercourse.

The mill, a rectangular industrial building constructed in coursed lias stone is three-storeys high with an attic floor (Fig. 5). The 34° pitched roof is supported on four tie-beam trusses positioned in line with the main floor beams. The floors were all 'open' and connected by enclosed straight flights of stairs situated against the west gable wall. Details of the mill machinery, provided by Martin Watts, are included in the survey report. In 1875 the mill was described as having 'working four stones'. In 1964 the upper floors of the mill were altered for domestic occupation which included the installation of a water turbine, now removed, to generate electricity.

*Fig. 5 Kingsbury Episcopi, Thorney, Thorney Mill, View across the R. Parrett showing external wheelhouse*

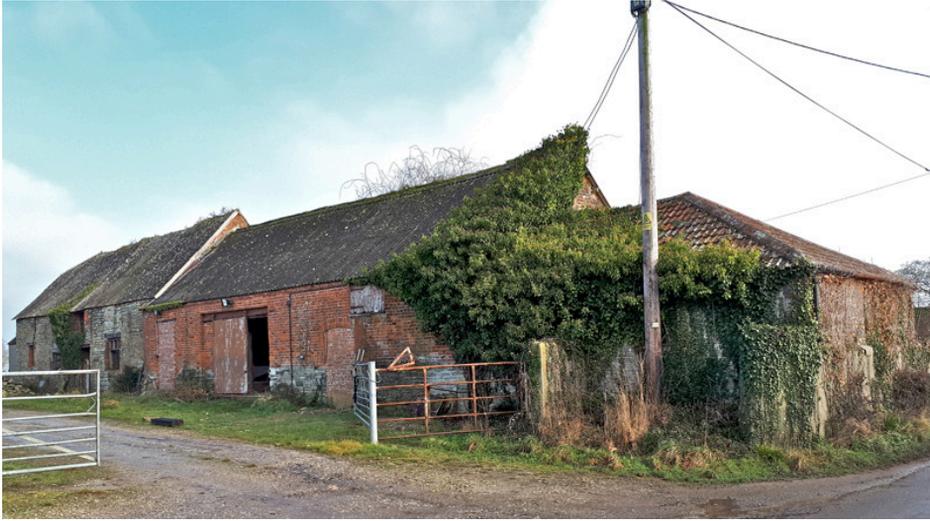
A single-storey range of farm buildings with five phases of build dating from the Agricultural Revolution, c. 1800 (Fig. 6). The two-storey principal barn, in the centre of the range, was built of coursed and squared local lias stone. Tie-beam and collar trusses support the probably half-hipped roof. It would have been variously used for the storage of high value grain and pulses.

*Fig. 6 Limington, Draycott Farm Barns, Stone and brick barns viewed from the south west*

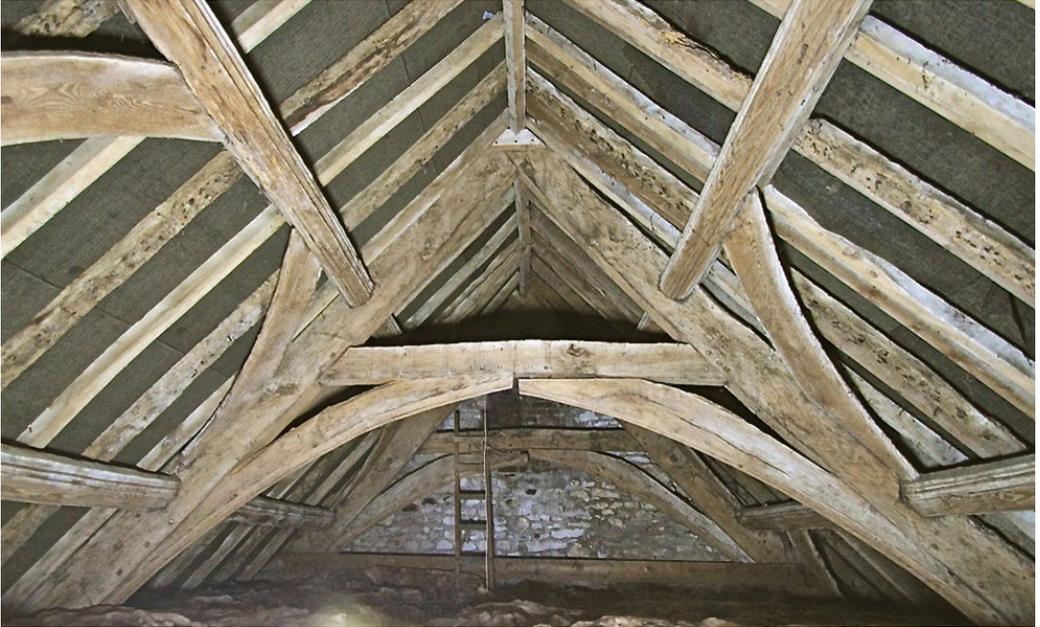
The roof, now showing multiple stages of repairs, is constructed of oak arch-braced collar trusses with a pitch of 50° (Fig. 7a). The principals meet with a plain tenon joint at the pierced apex. The trestle-sawn collars are slightly cambered and supported by moulded, open arch braces meeting at the centre of the span. The two tiers of moulded purlins house wind-bracing (Fig. 7b). This is clearly a roof structure that was meant to be seen and is free of smoke blackening, suggesting a purpose-built first floor hall. Jamb stones and the roughly broken doorstep of a blocked first-floor doorway in the south wall identify an earlier external access. The present doors and windows are of modern design and material but a remaining timber window frame with a diagonal chamfer stop of 15th-century style remains. All the current fireplaces are later insertions.

*Fig. 7a Milborne Port, 14-17 High Street, The west end of the high quality arch- and wind-braced roof*

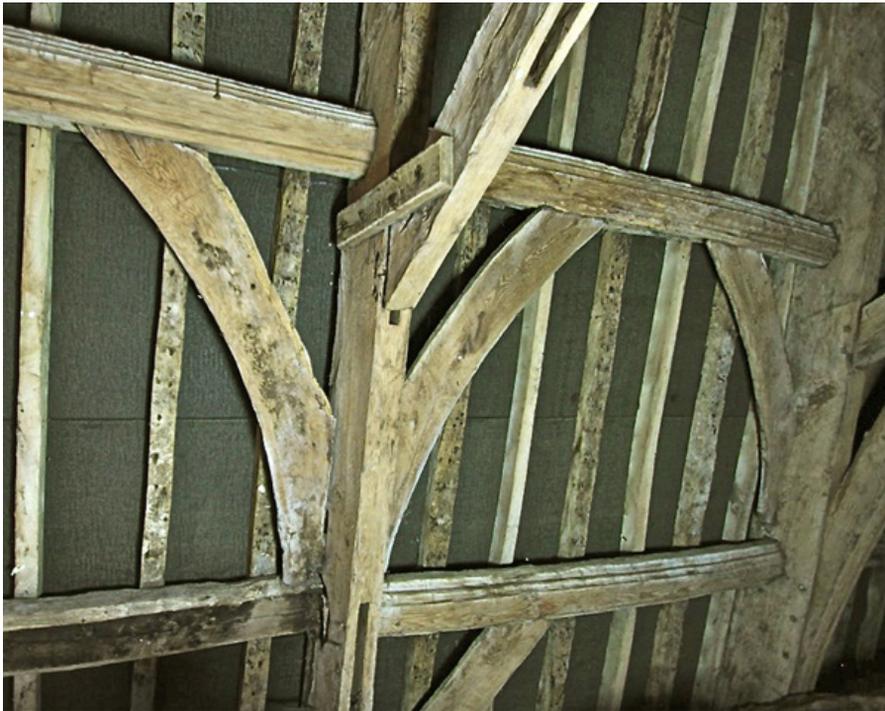
*Fig. 7b Milborne Port, 14-17 High Street, Detail of the purlins and wind braces, also empty arch-brace mortices*

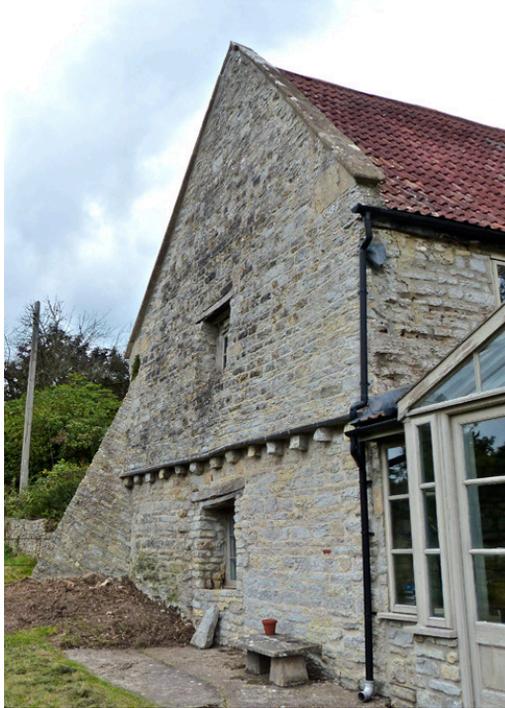
*Fig. 8a Pilton, Upper Westholme Farm, Stone-jettied west gable*

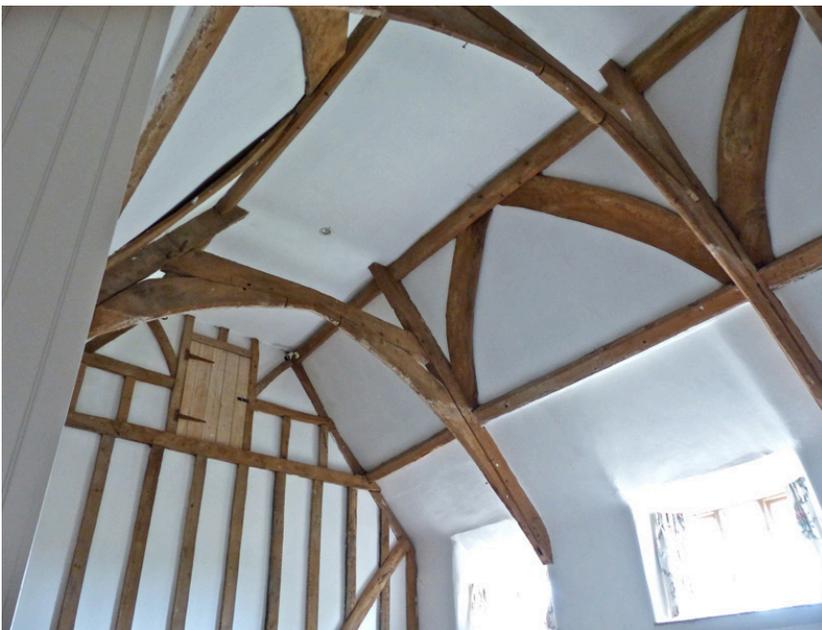
Once part of the Glastonbury Abbey estate, the main features of the house, particularly the arch-braced roof and the frame ceilings (Fig. 8b), point to a construction in the second half of the 15th century. The absence of smoke blackening of the roof confirms that it was built with a hall fireplace and chimney. The floor above the hall has a fireplace opening into this chimney and is probably original, heating a room that was open to the roof exposing the arch-braced collar trusses, deep cambered collars and wind braces. Extant detail in the property suggests high status: two framed ceilings, one of nine and the other of twelve panels, both beautifully, but differently, moulded. Doulting stone and Hamstone four-centre headed doorways with security bar slots in the jambs gave entry to the passage and dwelling and the winder stair in the turret was accessed from the hall via a

*Fig. 8b Pilton, Upper Westholme Farm, Roof in the domestic end of the house*

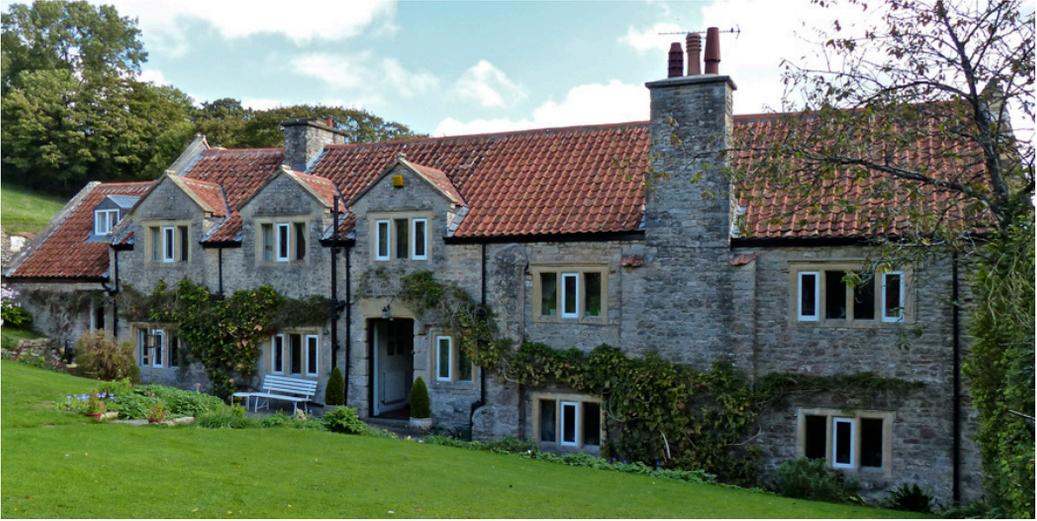
*Fig. 9 Shepton Mallet, Ham, Cleavers, Old and new mullioned windows on west elevation*

The farm was sold in the 1920s and planning permission for conversion to a dwelling was obtained in 1937. Use of 17th-century style mullioned windows, some original to the period, gives the house its 'old' appearance (Fig. 9).

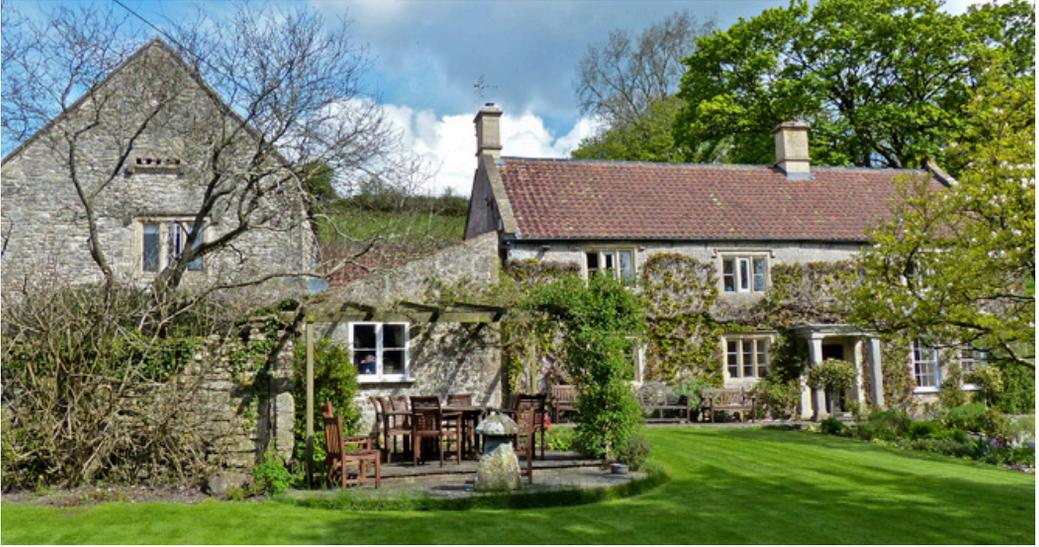
This listed property comprises a two-storey main range (Fig. 10) linked by a single-storey unit to a two-

*Fig. 10 Shepton Mallet, Ham, Ham Manor; South elevation showing the three elements of the house*

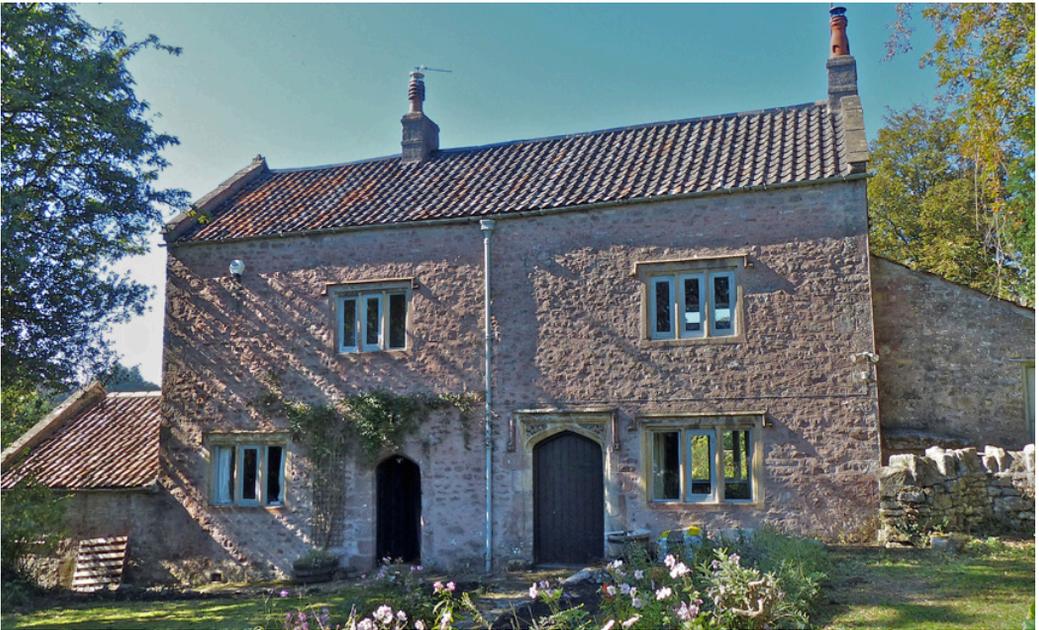
*Fig. 11 Shepton Mallet, Ham, Old Manor; left-hand door is 15th century, right-hand door is 19th century Mullioned windows inserted*

The house is a listed two-storey property with attics built of local limestone rubble with squared quoins (Fig. 11). It was formerly an unheated non-residential building - a barn. The main part was probably built in the mid-17th century as a barn/storehouse. The four-centred entry doorway may date from the late 16th century. An in-line, adjoining but originally unconnected, building was erected in the late 18th century, and in the mid-19th century there was another addition on the west side. Evidence for late 19th-century conversion to a dwelling can be seen in the stair window, the brick chimney stacks and the roof all creating a dwelling that gave the appearance of an old house with ovolo moulded mullioned windows.

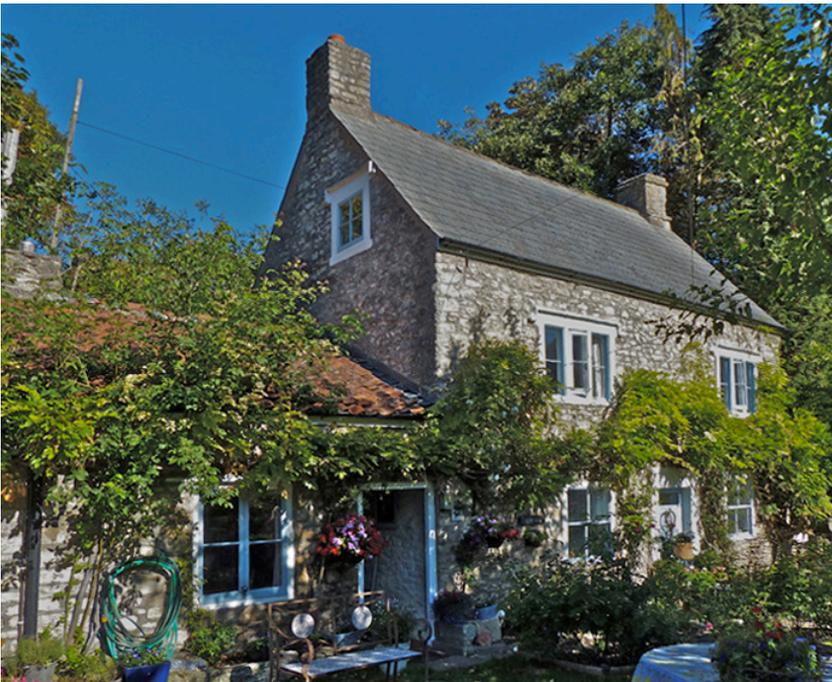
This small, listed house backing onto the mill leat comprises a two-room main house (kitchen/living room and an unheated parlour) of two storeys and attic in height (Fig. 12). It is built from local rubble stone with squared quoins, and has two single-storey in-line extensions. Extremely steep newel stairs rise through to the attic.

The front elevation has windows symmetrically arranged and a central entrance door. The upper windows, front and gable, have hood moulds above stone bead-edged surrounds (Fig. 12); the ground floor has sash windows beneath timber lintels. The front door also has a stone bead-edged surround.

Fig. 12 Shepton Mallet, Bowlish, Wells Road, Weirside, Hood moulds over 18<sup>th</sup>-century first-floor windows

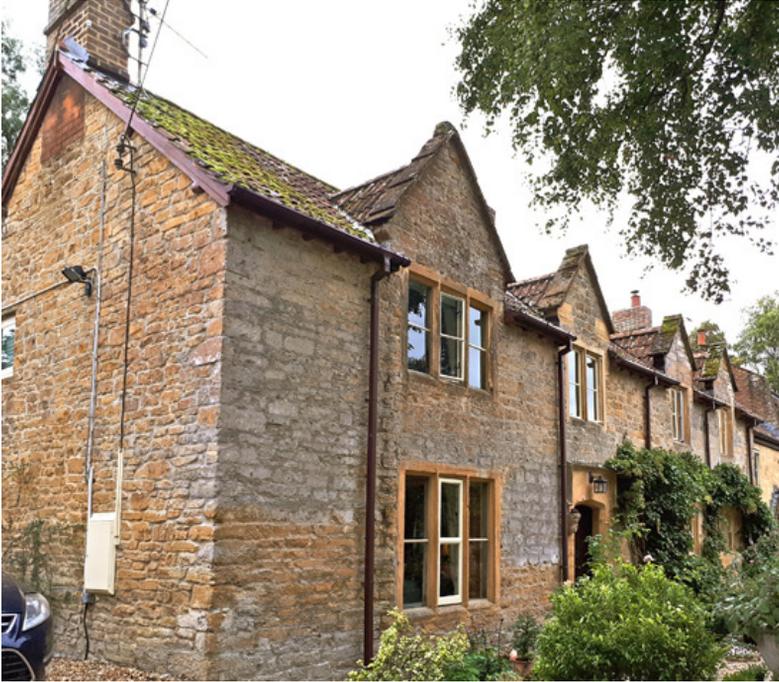
*Fig. 13 South Petherton, 24 Silver Street, Kings Pleasure, House viewed from north east*

Formerly known as 24 Jugglers Hill, this is a listed building of two storeys constructed from coursed, well-cut and faced Hamstone and some local marl stone (Fig. 13). The plan is rectangular and suggests a three-unit cross passage build, perhaps of c. 1600, with later rear extensions. However, the walls to the east of the cross passage are thinner, at 0.5m, suggesting a rebuild in c. 1800. An almost completely concealed post by the entry door may be the base of a cruck truss, a surviving remnant of a single-storey medieval open hall house constructed from cob.

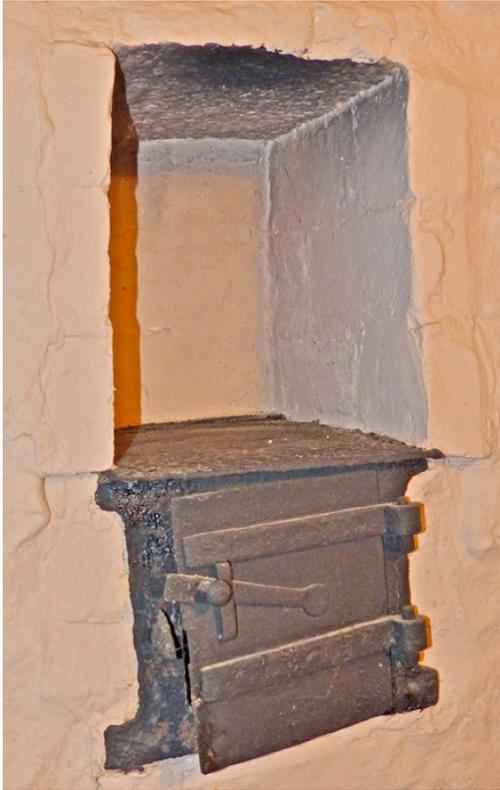
*Fig. 14 Sparkford, Little Weston, The Dairy House, Summer oven within the large inglenook*

Early in the 18th century a single-storey extension was added on the south gable. This became the kitchen with a large fireplace incorporating an oven and a summer oven (Fig. 14); new doorways created a cross way against the original gable wall. A second floor was constructed above this in the late 18th century, part of the lean-to has similar stonework. The present staircase may date from this period. A fourth phase of development occurred in the late 19th century with the introduction of fireplaces on both floors at the north gable.

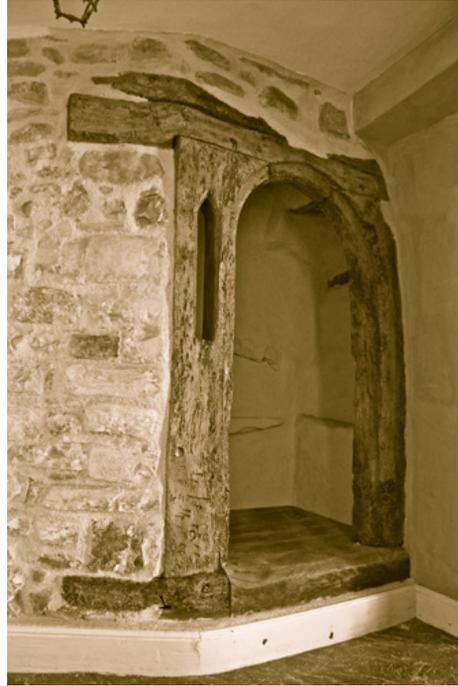
A south wing was added that comprised a hall and a parlour separated by a cross passage that led into the courtyard. The combination of five arch-braced jointed crucks, with posts extending to within 2.3m of the ground, and possibly three tiers of wind-bracing suggests an early 15th-century build for this, the main element of the complex. This date would be appropriate for the style and construction of the oak, four-centred arch head front door and the quatrefoil design on the imposing stone fireplace lintel. The hall was open to the roof whilst the room over the parlour was a private chamber or chapel complete with wagon

roof and accessed by a turret stair (Fig. 16).

*16 Williton, Doniford, Doniford House, Door frame with pierced window at foot of solar stair turret*

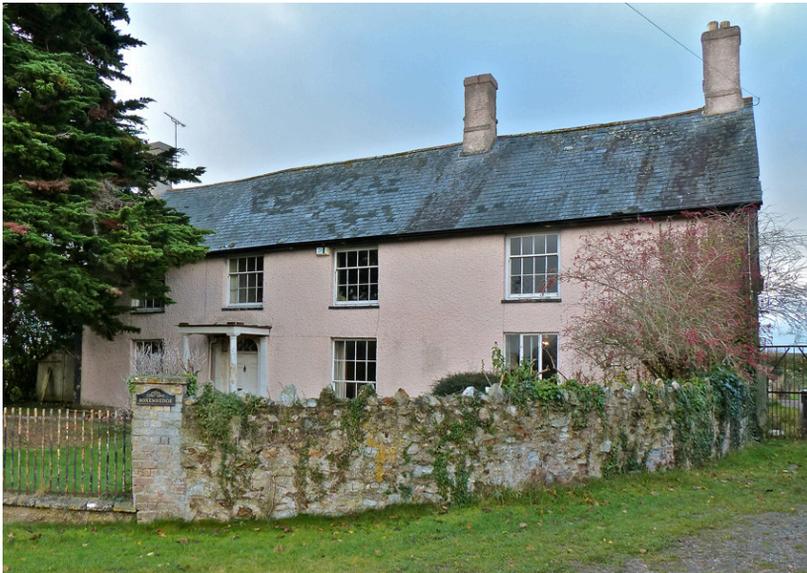
This listed property has a plan of two rooms either side of an entrance hallway, a further in-line room to the west, two rear wings and a stair turret (Fig. 15). Wall thicknesses vary; some walls are of cob indicating a possible earlier building on site. Walls are rendered and colour-washed beneath a roof of asbestos slates,

Regency features can be noted: the Doric portico; the split six-panel entrance door with an elliptical fanlight; ceiling-to-floor sash windows in slender, unreinforced frames on the ground floor; ceilings 2.5m high, reflecting the late 18th-century fashion for high ceilings. Further improvements occurred in the late 19th century, primarily with the raising of the roof to incorporate taller first floor windows. Subsequent changes have been minor.

*Fig. 15 Trull, Dipford, Boxen Hedge, Regency styling to the front elevation*
